Bank Underground Station Capacity Upgrade (BSCU)

Dragados/ London Underground Ltd

Bank Underground Station

Capacity Upgrade (BSCU)

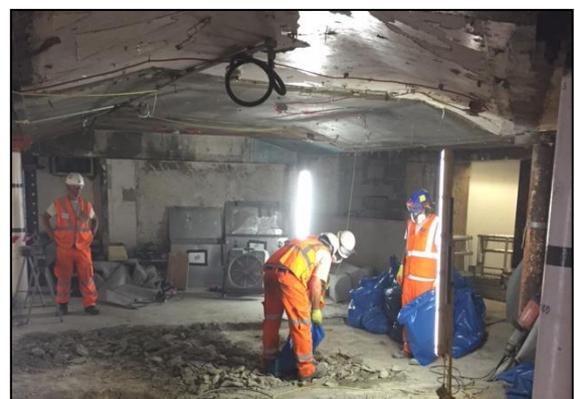
New large blast proof HV and LV rooms for the Central Line power upgrade were built within the space vacated by the old staff accommodation (and station supervisor's office). The works consisted of:

- Erection of fireproof hoardings as part of the site set up
- Demolition and strip out of the internal rooms
- Removal of the existing structural screed in all areas and the installation of new
- Coring 800mm station walls (requiring staged and complex temporary

works/metal propping as they are located directly beneath the intersection of roads above) to facilitate the installation of entrance doors and large openings (for the ventilation ducts)

- Coring floor slots and access openings between rooms for new HV/LV cable routes
- Formation of new concrete encasements around existing support beams
- Installation of blast proof new block walls and wind posts to create new rooms
- Installation of SR1 and SR2 fire doors and fire compartment rooms
- Floor, wall and ceiling painting
- Finishes and tiling work throughout.
